**Micro-Chemical Explosive Residue and Blast
Damage Analysis Concerning the Events at the
Branch Davidian Complex in Waco Texas**

Prepared for the Office of Special Counsel

**Dr. Gerry Murray
Forensic Science Agency of Northern Ireland**

**Mr. David A. Green
Lake County Regional Forensic Laboratory (OH)**

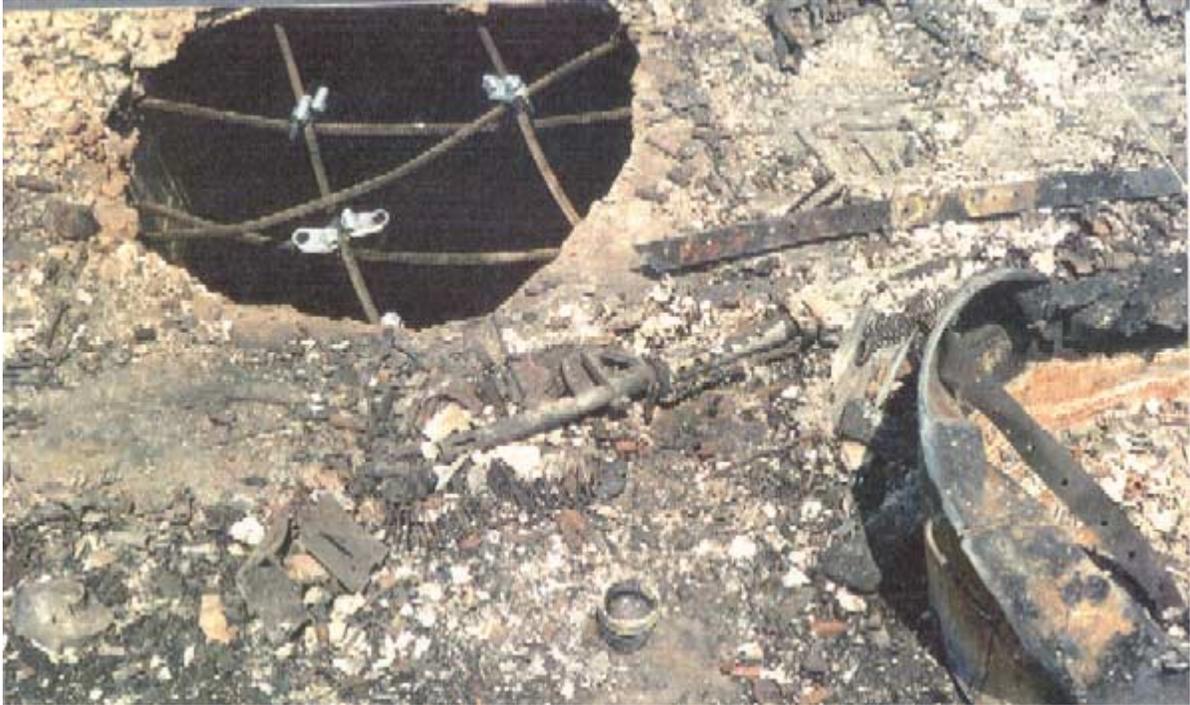
While it is our opinion that the 47 centimeter hole located in the roof of the concrete bunker does exhibit some characteristics consistent with a shaped charge, namely, the round shape of the hole, this is not determinative that a shaped charge created the opening. The condition of the concrete bunker must be taken into consideration. Dr. Ulf Wickstrom, a fire expert of the Office of Special Counsel, has stated that spalling (see section 5.2 of this report) caused the hole. Ronald E. Koester, an engineer for the Texas Department of Transportation Waco, Texas district, also stated that he believed the hole may have been caused by some type of heavy object, due to the spalling. Therefore, while it may be true that a shaped charge may cause a hole, with characteristics similar to the hole in question, the shape of the hole is not determinative of the cause of the hole.

Figure 1: The above photograph depicts the questioned hole in the roof of the concrete bunker. Notice the four(4) u-bolts used on the reinforcement bars for safety precautions and the bowing of the reinforcement bars

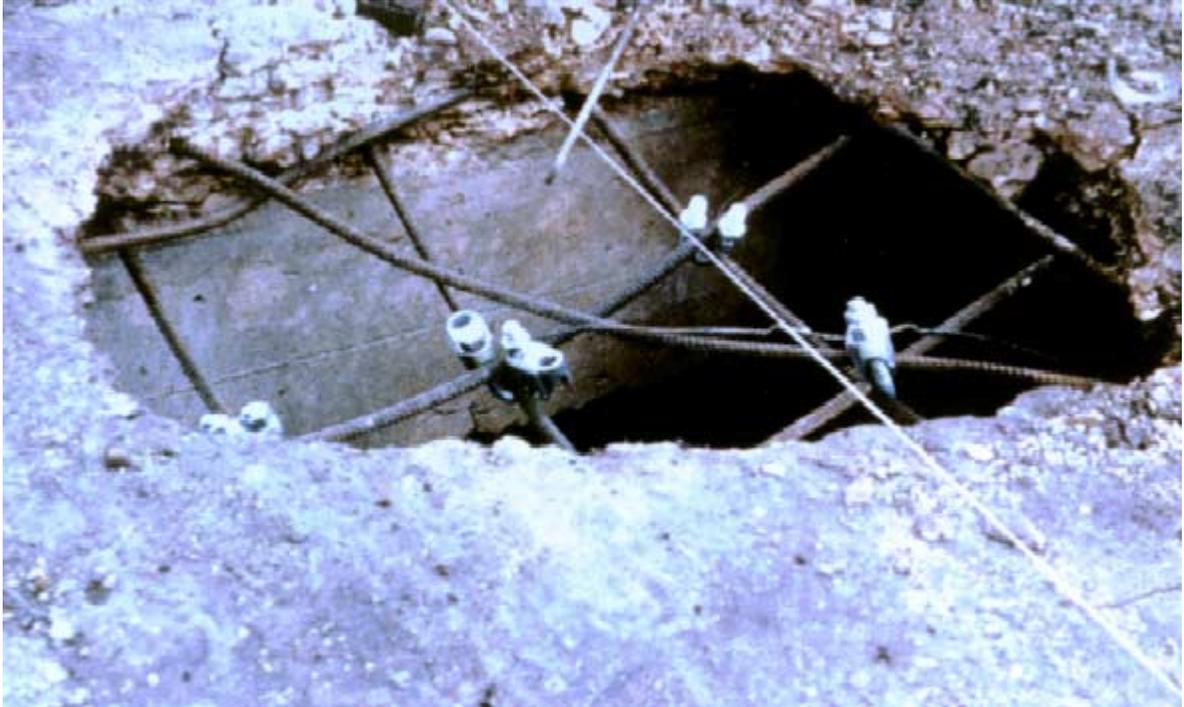
Figure 2: The above photograph depicts the circular hole in question. Note the shape of the hole, and the reinforcement of the metal bars.

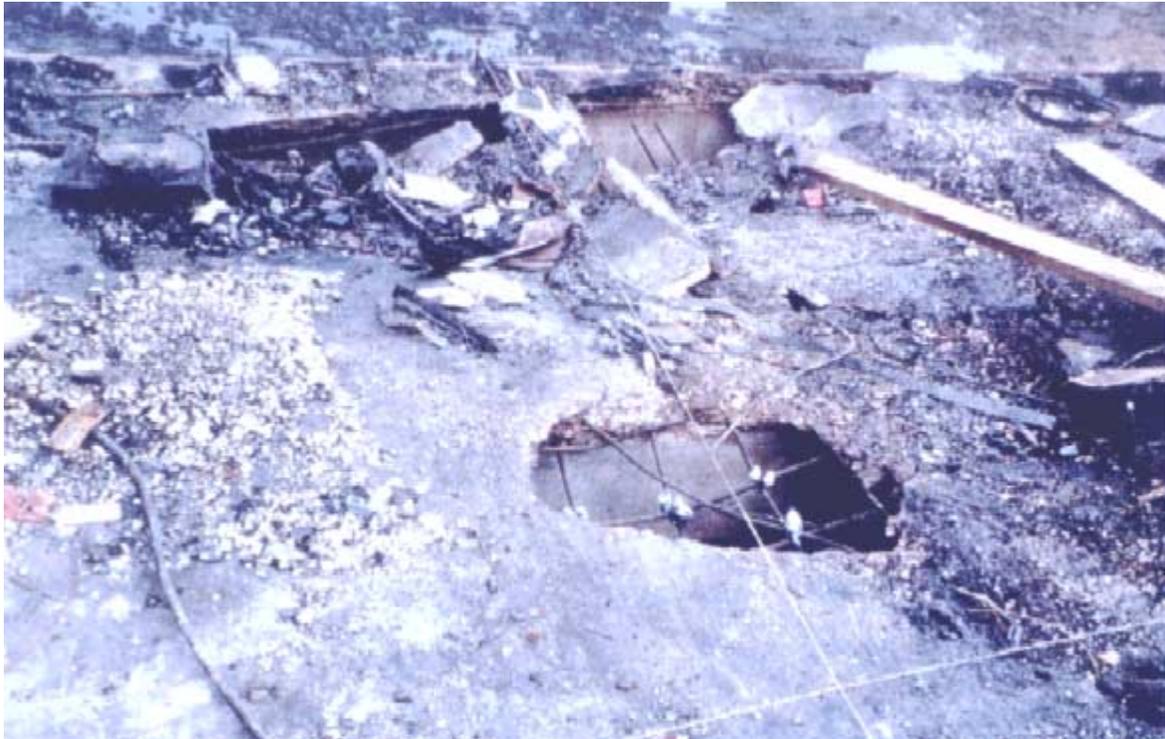
There are various photographs of the concrete bunker roof, both from the outside and from within. One photograph depicts a roughly circular hole, with bent or bowed lengths of reinforcing bar clearly visible. Although the bars are deformed, there is no apparent evidence of high order explosion damage. Close to this hole is what appears to be the barrel of an M16 rifle, see Appendix 2, Figure 1. Using the distance from the front of the barrel to the front of the sight as a reference, we estimated the diameter for the hole to be approximately 47 centimeters. As observable in several of the photographs, it was necessary for law enforcement officials to reinforce the roof before removing the bodies and collecting evidence from inside the concrete bunker do the unsafe conditions of the roof. See Appendix 2, Figure 2, which depicts the reinforcing knuckles on the sagging reinforcement bars. This is not the only hole in the roof. Heat damage and sag have also opened up holes along the perimeter of the bunker roof, see Appendix 2, Figures 3, 4, 5 and 6.

Figure 3: The above photograph depicts the circular hole located in the center of the bunker as well as several other hole located in the roof and their proximity to one another.

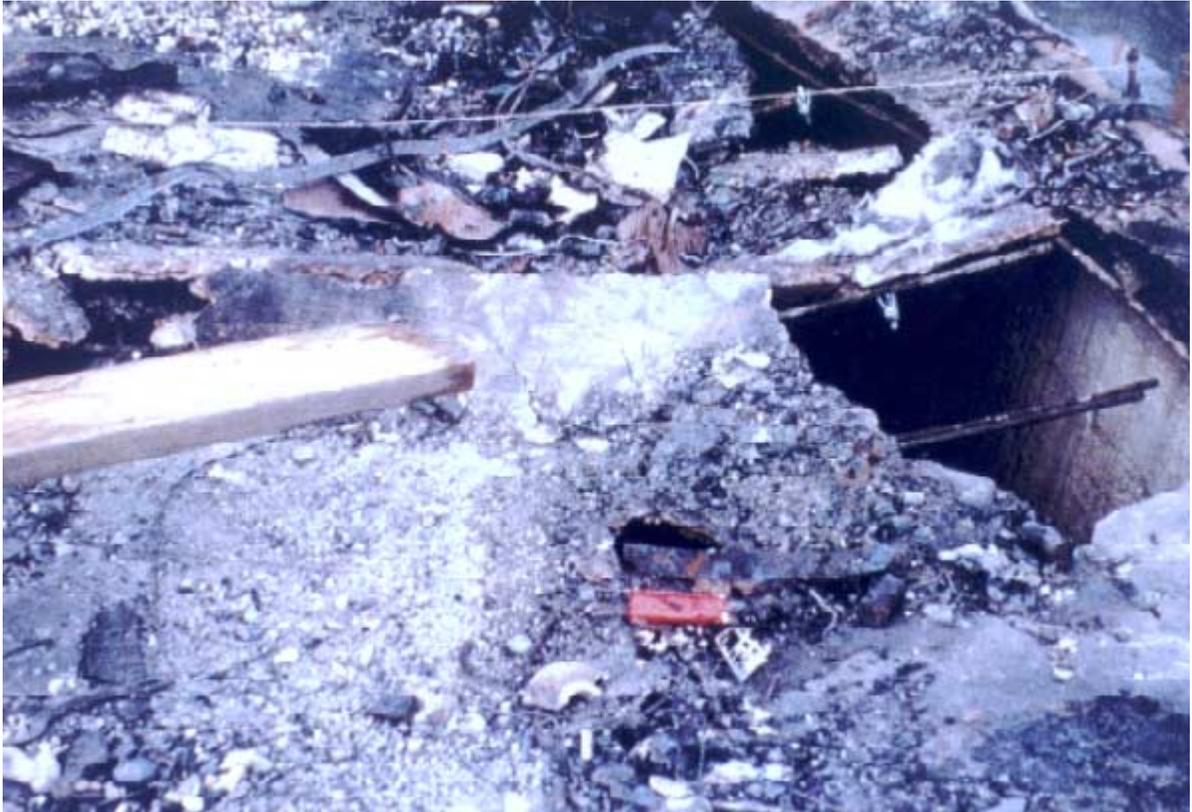
Figure 4: The above photograph depicts holes located in the roof of the concrete bunker. These holes occurred at the edge of the roof, several feet from the circular hole located in the center of the bunker roof (which can also be observed in figure 3).

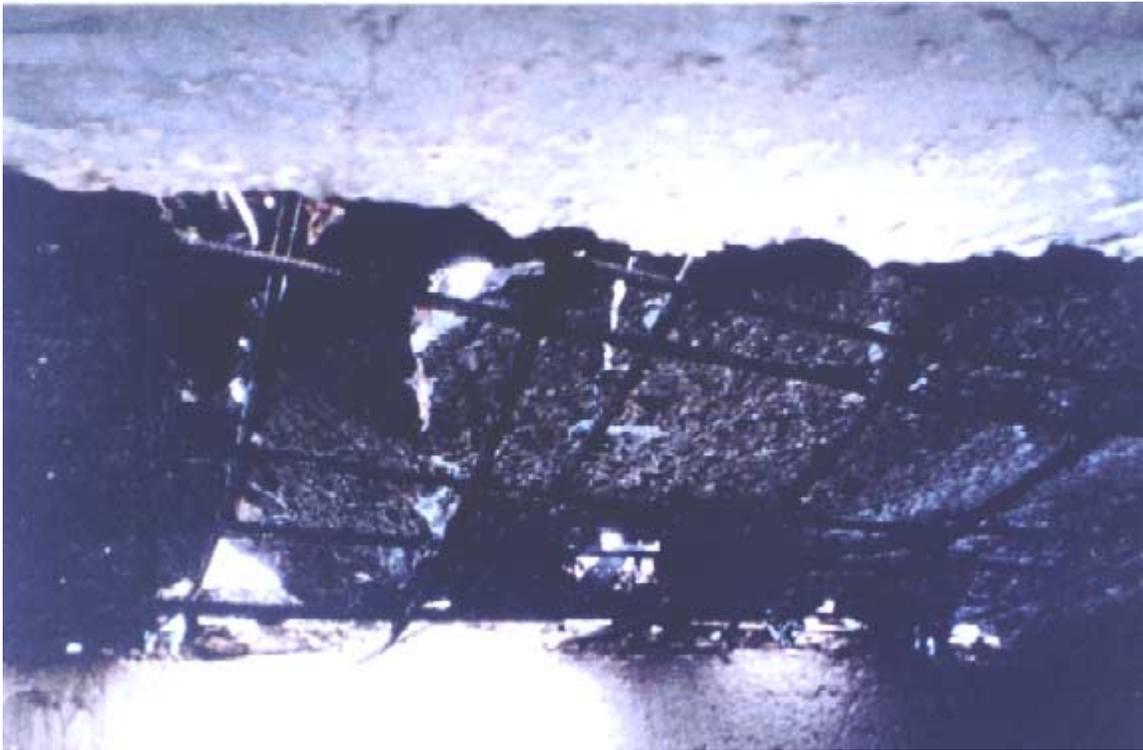
Figure 6: The above photograph depicts the ceiling region inside the bunker. Note the pieces of concrete missing, due in part to the spalling phenomenon. Also note that several holes are present in the ceiling, not just single circular hole in the center area of the roof.

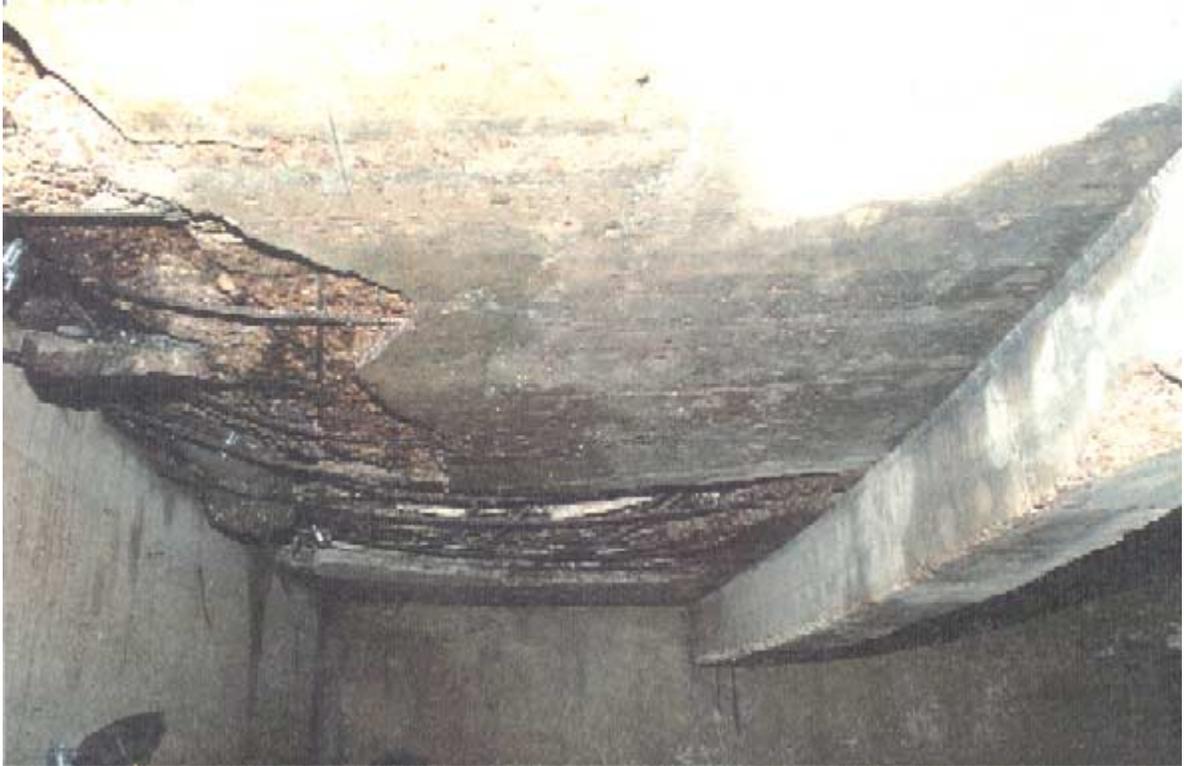
We understand that Office of Special Counsel fire expert, Dr. Wickstrom, has determined that spalling significantly damaged the roof of the bunker. Photographs of the inside of the concrete bunker show areas of this spalling on the ceiling, one around the hole through the roof and another nearby, although there has been no penetration of the roof in the latter case, see Appendix 2, Figure 7.

Figure 7: The above photograph depicts the extreme damage to the concrete on the ceiling of the bunker. Notice the “bowing of the ceiling and the pieces of concrete missing from the underside of the reinforcement bars.

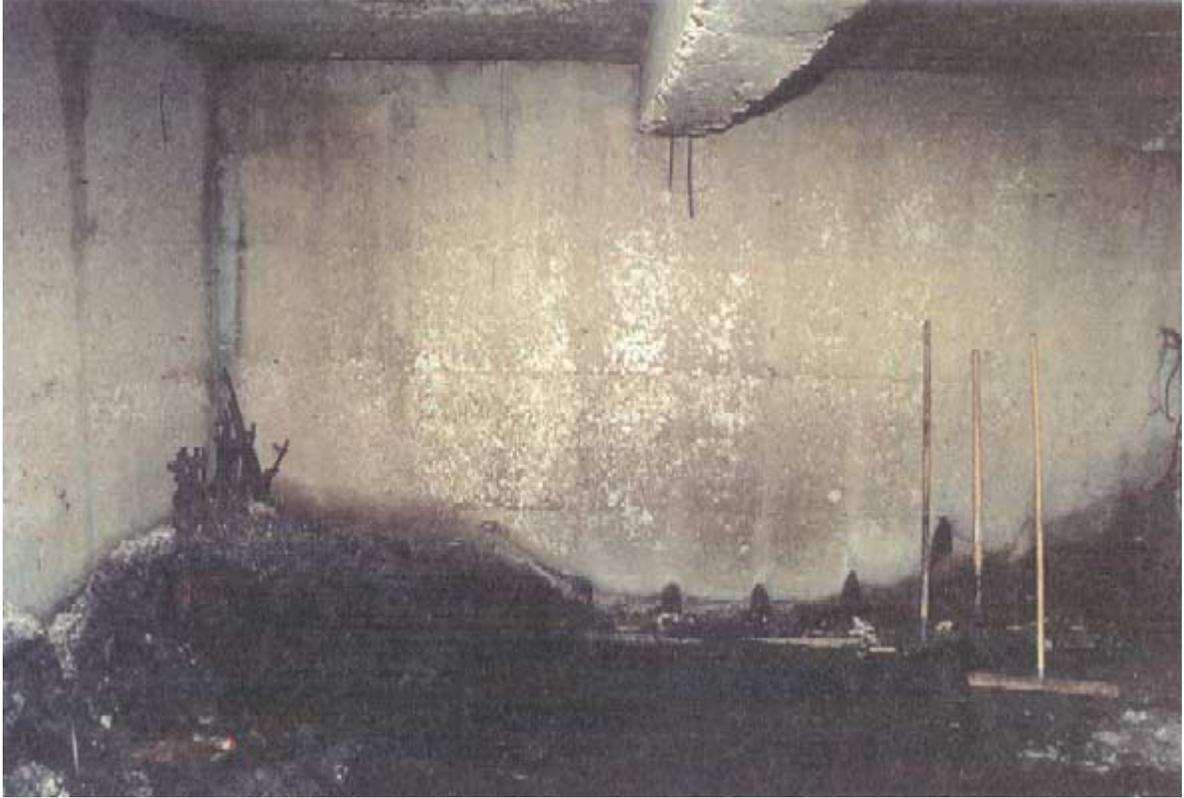
The interior photographs also show a significant number of firearms in the concrete bunker, see Appendix 2, Figures 8. The photo in Appendix 2, Figure 9, shows the hole in the concrete bunker roof and, nearby, at approximately the 4 o'clock position, what appears to be a circular depression.

Figure 8: The above photograph again depicts the condition of the inside of the concrete, which constructed the bunker. Notice the pitting (missing pieces) on the concrete walls as well as the concrete beam in the ceiling.

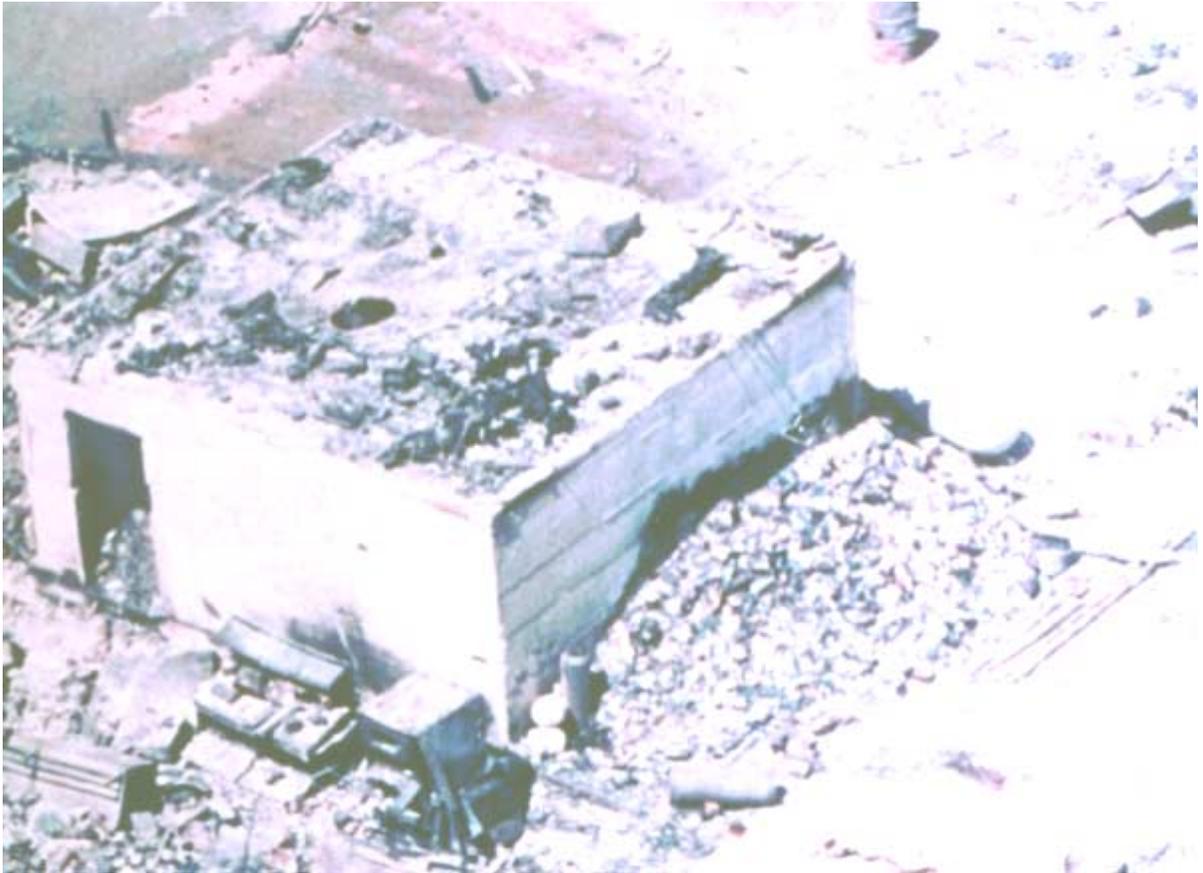
The FBI Laboratory report of 6 December 1993, addressed to Sargent Miller of the Texas Rangers, advises that "Damage to the outside top of the concrete roof of the bunker in Search Zone M is consistent with at least two seats of explosions". The roof of the concrete bunker was designated by law enforcement as search zone M.

Figure 9: The above photograph depicts the overhead view of the concrete bunker. Notice the hole in the “center” of the bunker, along with the second circular mark at the 4 o’clock area.

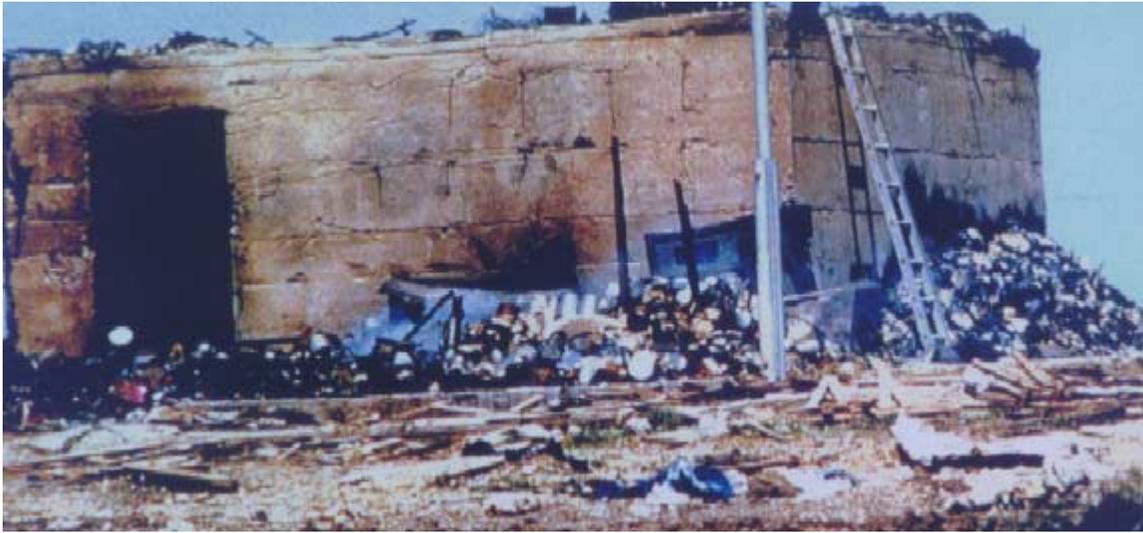
The walls of the bunker exhibit numerous cracks to various joints and throughout all four walls. These cracks are documented in several photographs, see Appendix 2, Figures 10, 11, and 12. The bunker was levelled by law enforcement officials because of safety

This is a significant finding, since persons within the concrete bunker, particularly in the area below the hole, see Appendix 2, figure 10, would have been subjected to blast damage from the explosion. If a shaped charge had detonated, the large amount of pressure caused by the explosion would cause damage to the occupant's lungs and injuries from the high velocity impact from concrete. Based on the absence of these characteristics, injuries on individuals found inside and on top of the bunker, i.e. proximate to any alleged explosion, and other details explained in this report, it is the opinion of the examiners that a shaped charge could not have been detonated.

Figure 10: The above photograph depicts the front and side of the concrete bunker. Note the condition of the walls of the structure, specifically, the cracks and pitted areas located all over the outside walls.

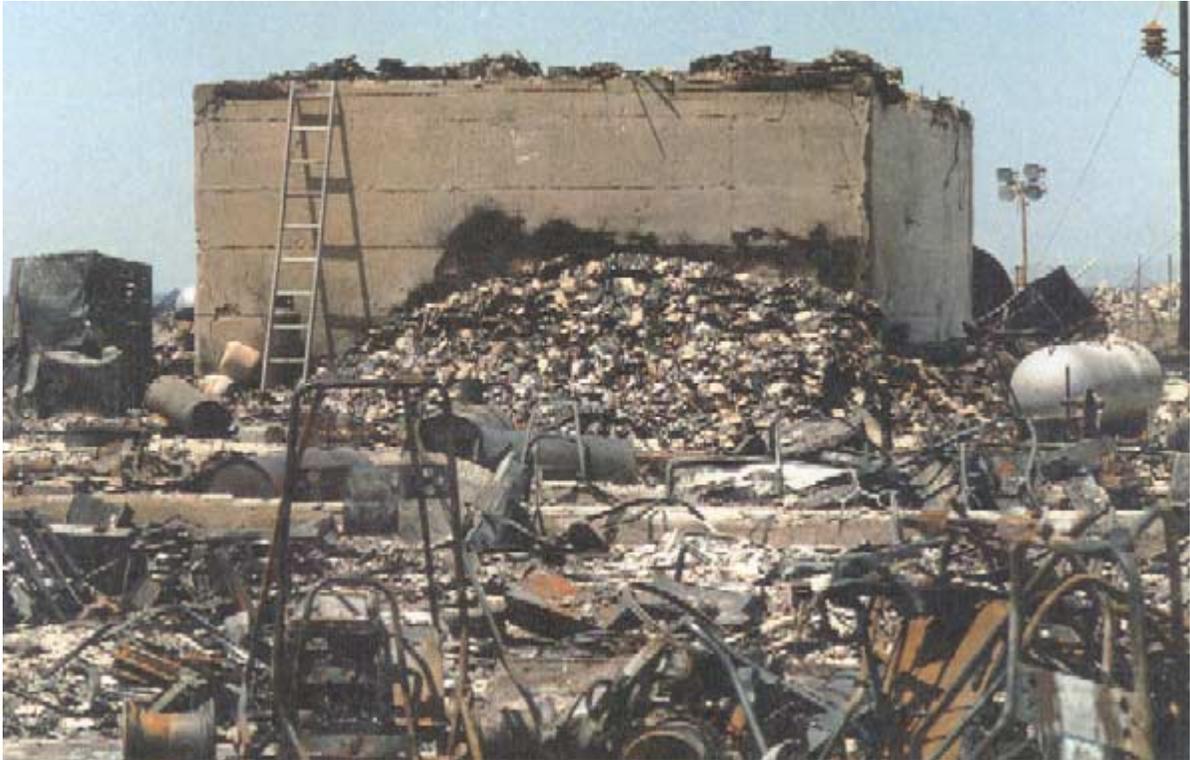
Figure 11: This photo depicts the back of the concrete bunker, note the condition of the concrete on the walls, with regard to cracks and pitting.

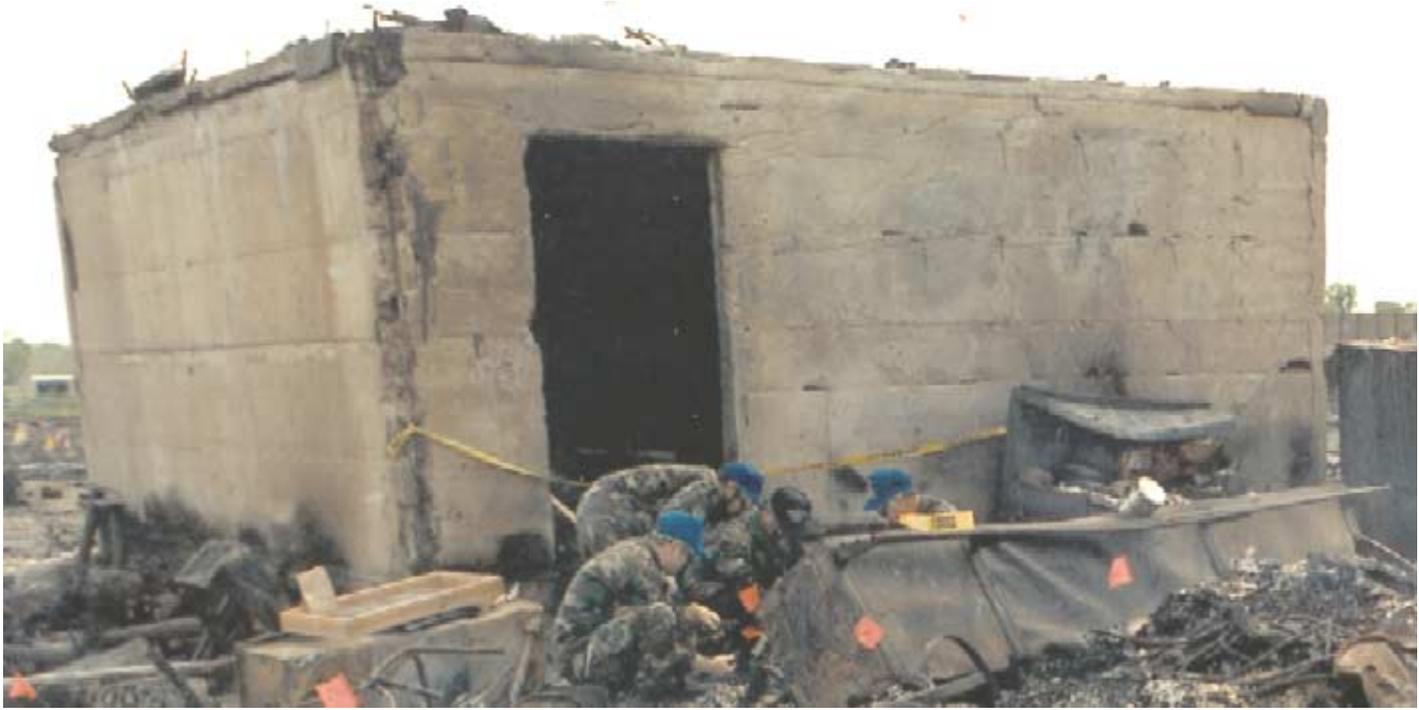
Figure 12: The above photo depicts the condition of the concrete bunker from the front side. Notice the cracks and pitting on the outside surface. There is enough space in front of the doorway to allow several men to work.

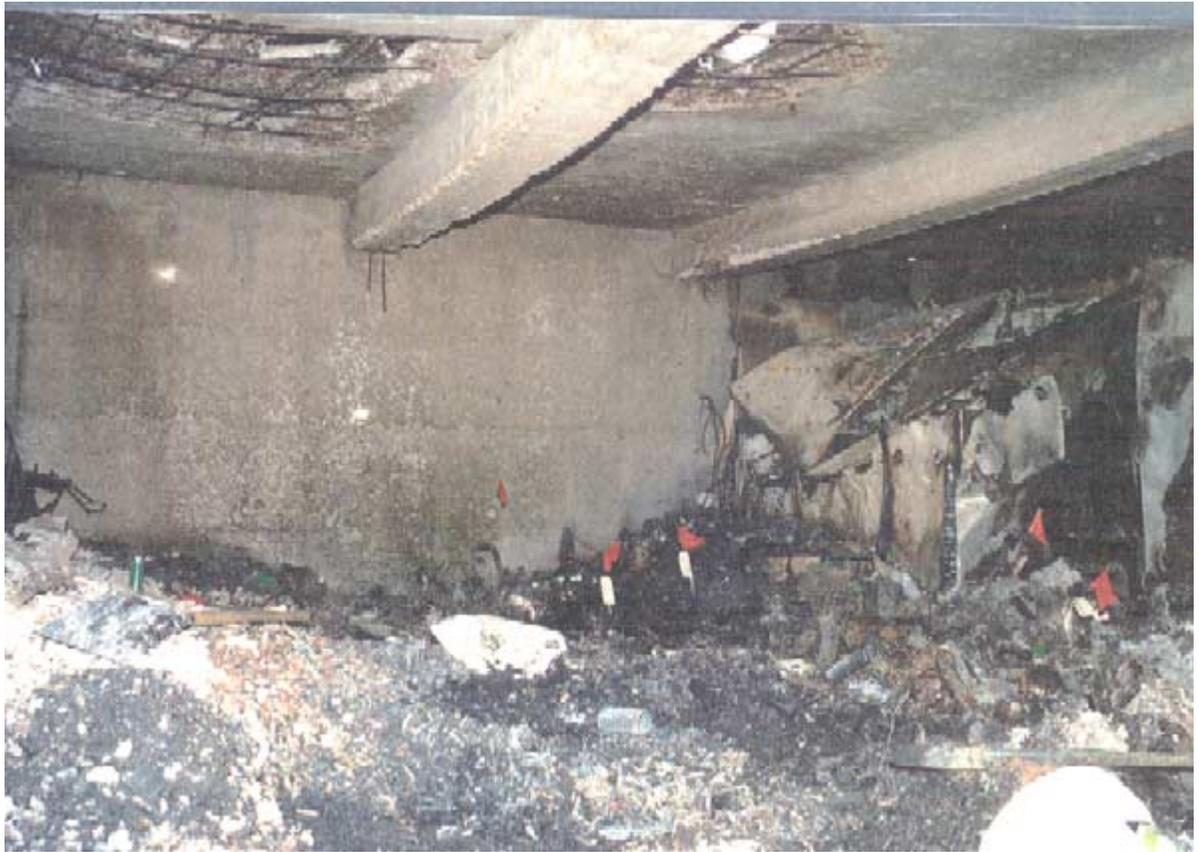
Figure 13: The photograph depicts the inside of the concrete bunker. Note the “bowing” of the concrete ceiling, the pitting or spalling of the concrete ceiling beams, the condition of the metal object along the wall. Notice the metal object, or cooler, is not directly under the hole in the center of the bunker roof.

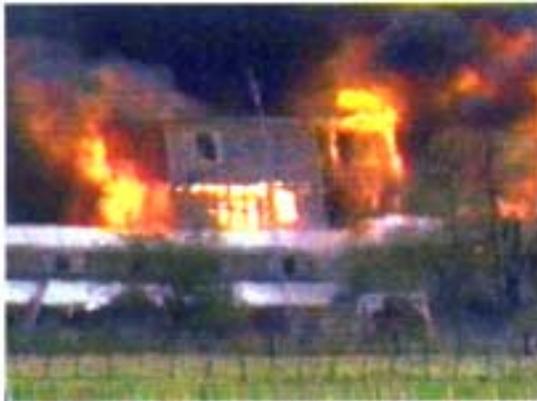
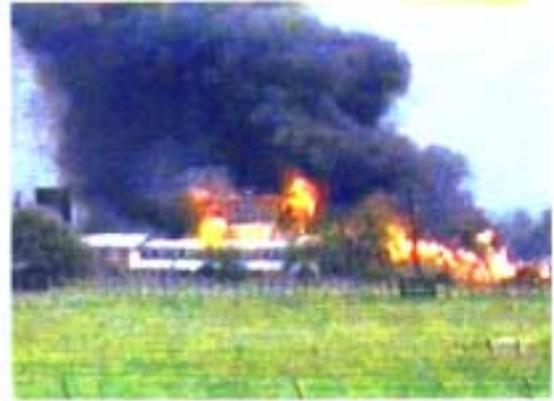
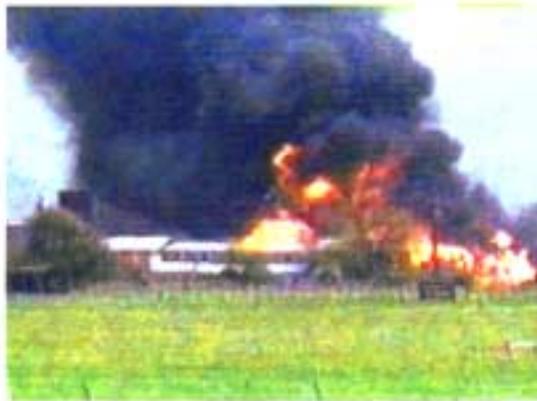
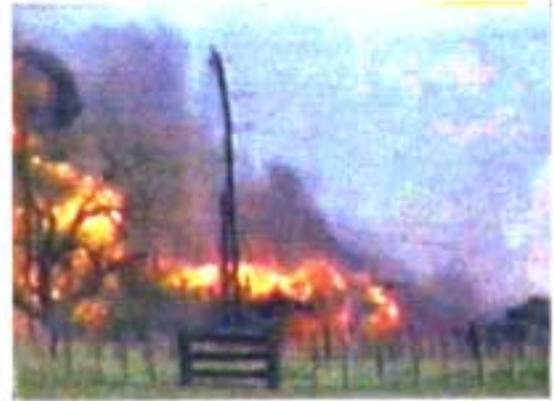
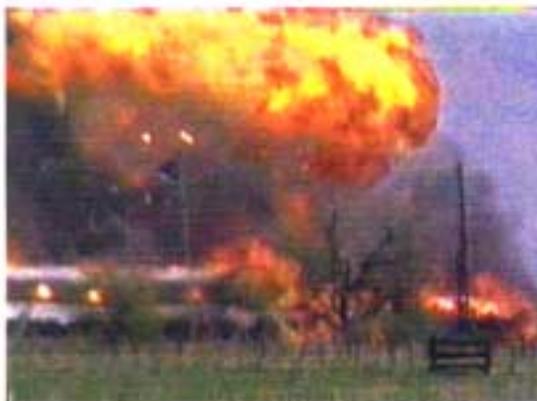
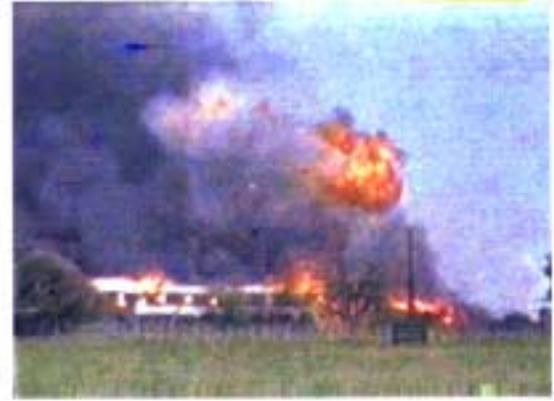
TOWER COLLAPSE AND PROPANE TANK EXPLOSION (ELAPSED TIME IN SECONDS)

Finally, Gen. Partin in his declaration states, "the explosion process reveals that the first show of bright, white light from the explosion comes from the fourth floor window the left near the juncture of the front and left faces of the fourth floor walls." Gen. Partin is simply incorrect. Upon review of video supplied by the Office of Special Counsel, it is noted that the tower burnt down approximately seven minutes before the fire ball explosion is viewed, see Appendix 2, Figure 14.

Figure 14: The above series of photographs depicts still photographs created from video. The first frame exhibits the tower collapsing, from the fire, the next three frames depicts the fire burning as time elapses to the 7 minute 58 second mark, when a fireball explosion can be observed.

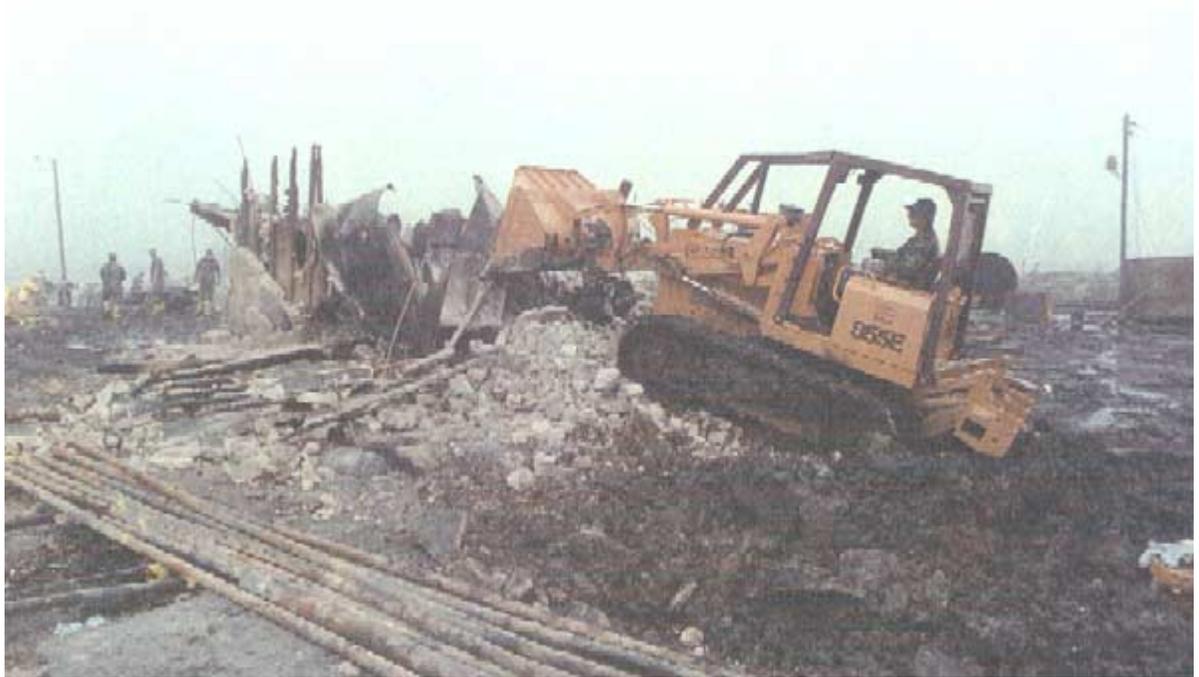
reasons, and this too is exhibited in several photographs, see for example Appendix 2, Figure 15.

Figure 15: The photograph depicts the destruction of the concrete bunker. According to statements this was conducted due to the visibly and physically unsafe nature of the bunkers condition.

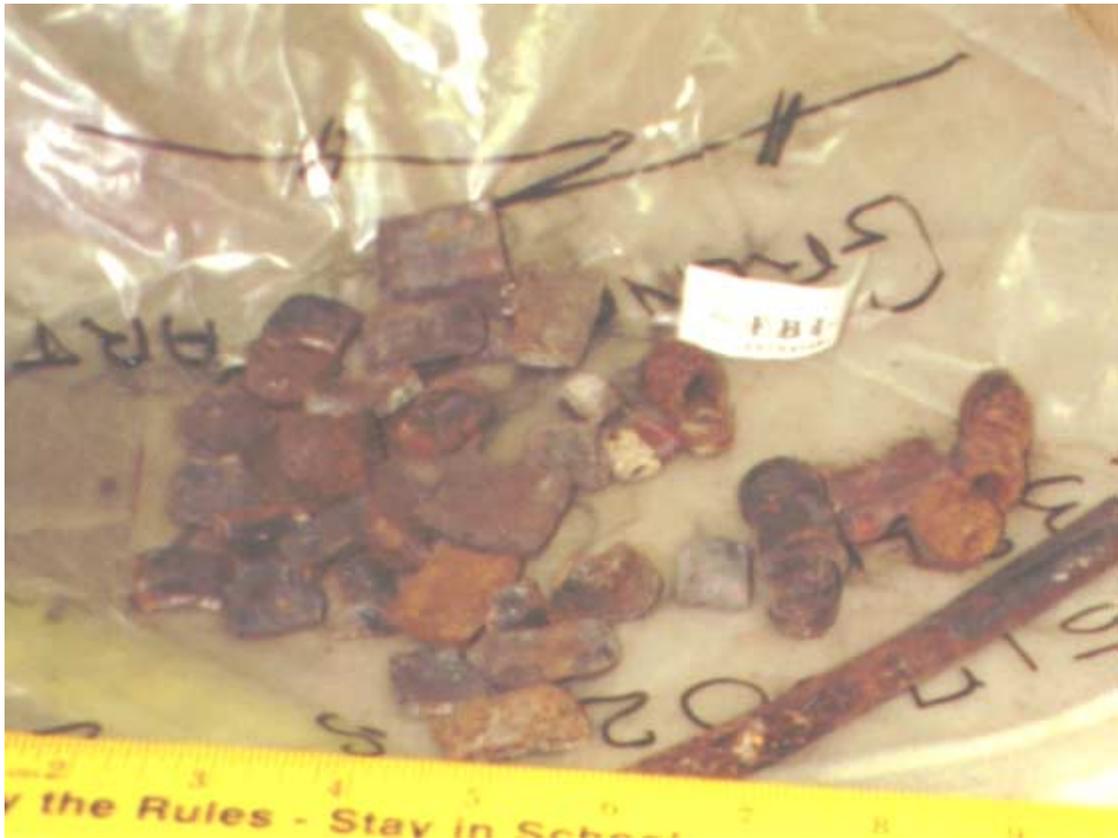
Figure 16: This photograph depicts pieces of grenade fragments which were collected from the roof of the concrete bunker.

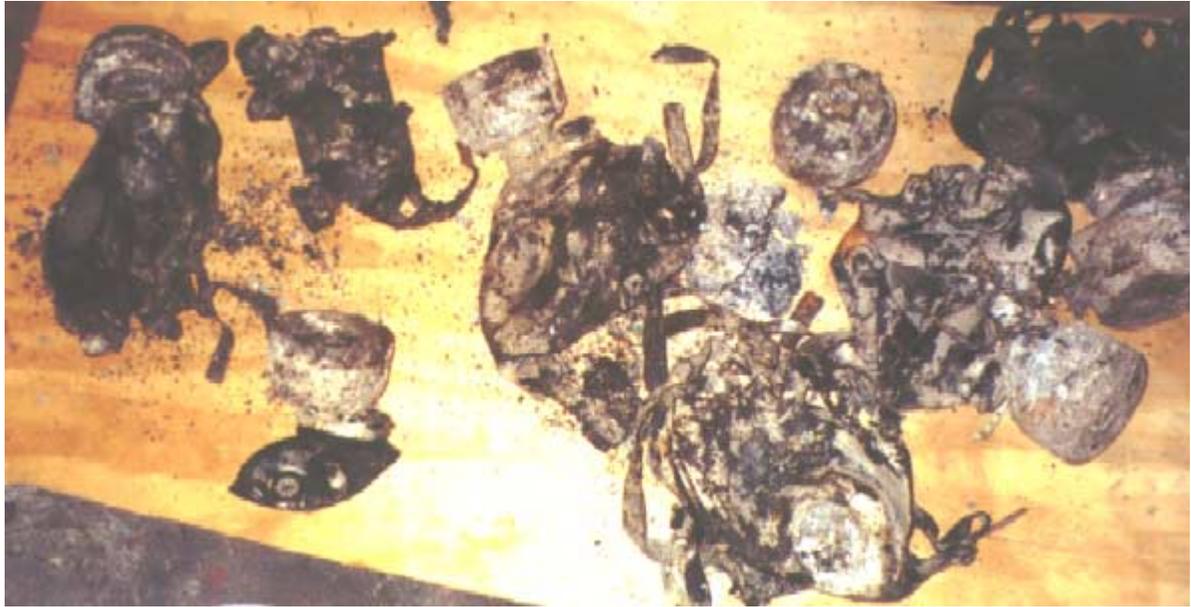
On May 24, 2000, while in Waco, Texas, Mr. Green also obtained sample swabs from four gas masks, see Appendix 2, Figure 17, originally recovered inside the concrete bunker, using the sampling technique previously discussed. These samples were collected because they were found in the area directly below the hole in the roof of the concrete bunker. These items were selected on the chance that they would contain any potential post blast residue due to their position near the hole. Mr. Green forwarded the samples, on July 10, 2000, to the Forensic Science Agency for examination, by Dr. Murray. The swabs were examined for the presence of material of an explosive nature. Nitroglycerine was detected on one of the swabs taken from one of the masks. The significance of the detection of nitroglycerine is minimized by the fact that nitroglycerine is present in small weapons ammunition. Countless numbers of spent rounds of ammunition were present inside and on top of the concrete bunker. The examiners therefore expected the detection of nitroglycerine.

Figure 17: This photograph depicts the masks that were “swabbed” by Mr. Green. The masks were labelled as having been collected from inside the bunker.

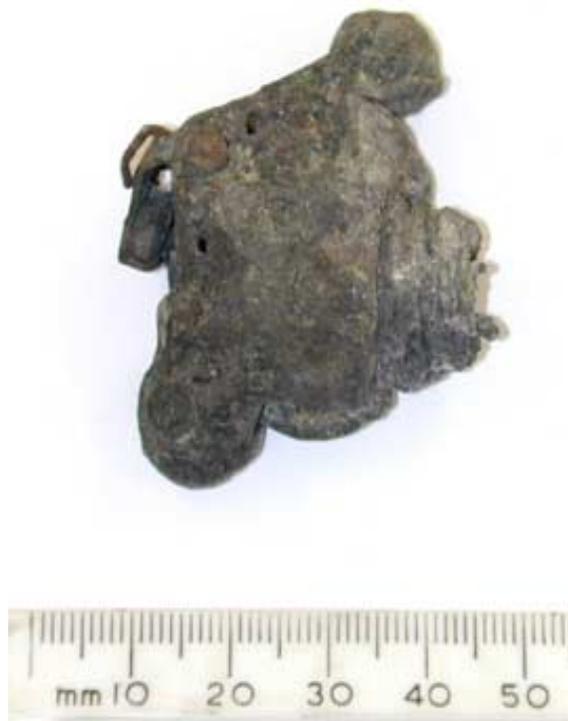
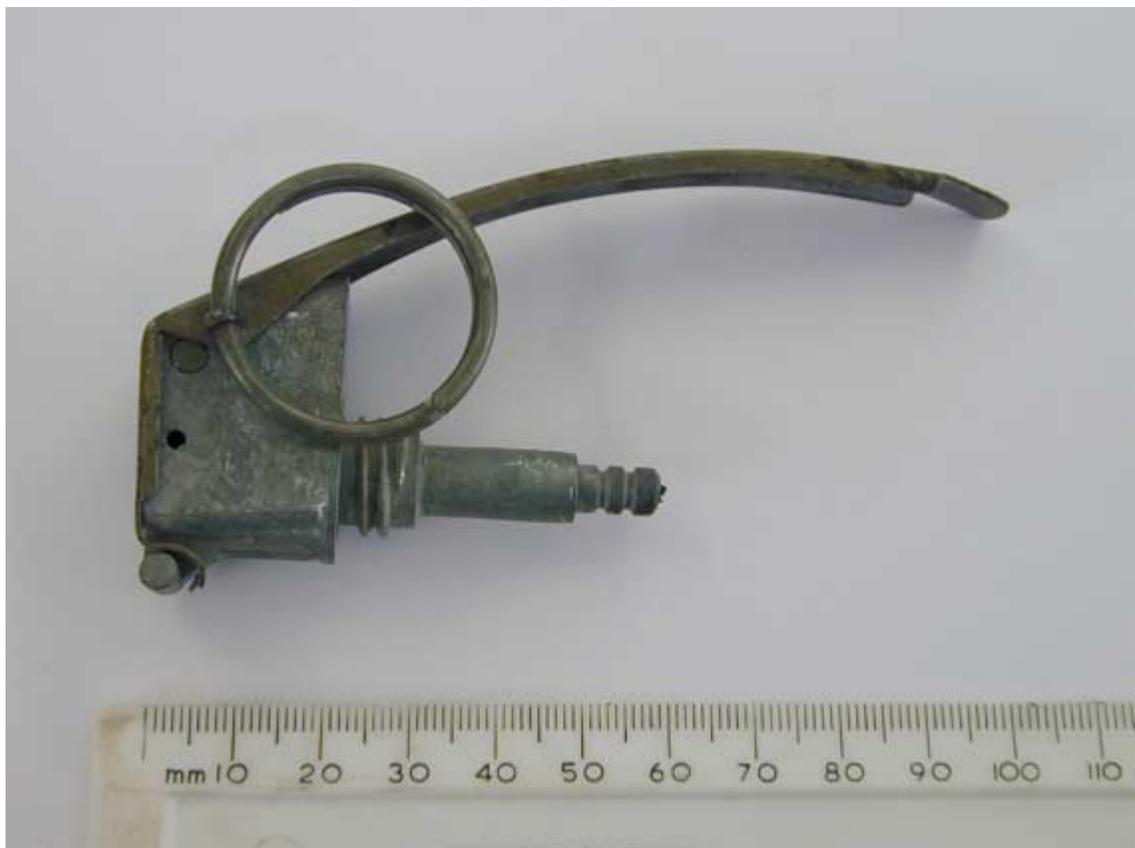
The second feature of significance was the remains of the grenade igniter set, see Appendix 2, Figure 18. The top section of the grenade igniter set contains a percussion cap and a spring-loaded striker. Prior to use, the striker is held back by a fly-off lever which is secured by a split pin/ring assembly, the pin being inserted through aligning holes in the top of the igniter set; the ends of the pin are splayed to prevent accidental removal of the pin. The pin must be removed before the fly-off lever can be ejected and the striker can hit the percussion cap. In the case of the igniter set, the striker had been

released. If a grenade, with the split pin in place, exploded, particularly if the explosive was a low order explosive, there would not be sufficient force to remove the split pin. Therefore, it appears that the igniter set in item 1610 had been deliberately activated. It is noted that Special Agent Ronald Knight stated that at approximately 1230 hours he heard what he thought were grenades exploding inside the Branch Davidian complex.

Figure 18: The lower photograph depicts a close view of grenade fragment. The top photograph depicts the grenade igniter set referenced in section 5.6 of this report.

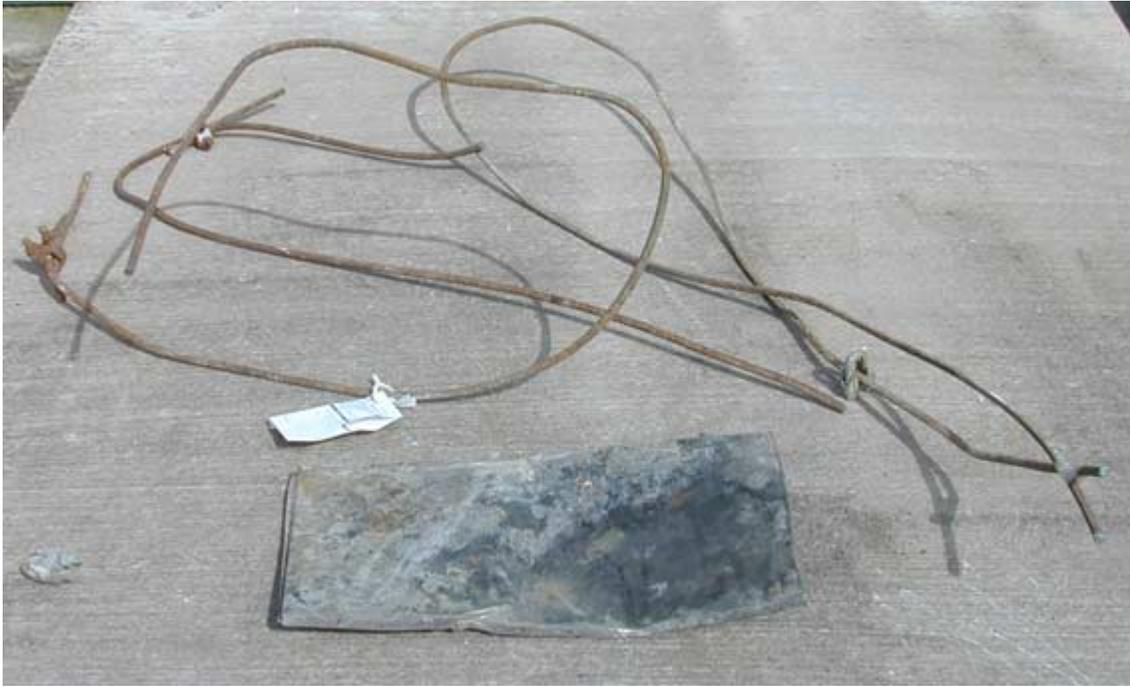
Materials such as nitroglycerine are quite volatile and will evaporate relatively quickly. High performance explosives, such as RDX or PETN, like that used in shaped charges, however, are non-volatile and can remain for long periods of time. Because traces of nitroglycerine were detected on the metal reinforcement bars, it is highly unlikely that traces of a high performance explosive, which deteriorate much slower, would not have survived as well. This is extremely suggestive that a high explosive was not used to breach the concrete bunker.

Figure 19: This photograph depicts the reinforcement bars, which were tested for the presence of explosive residues.

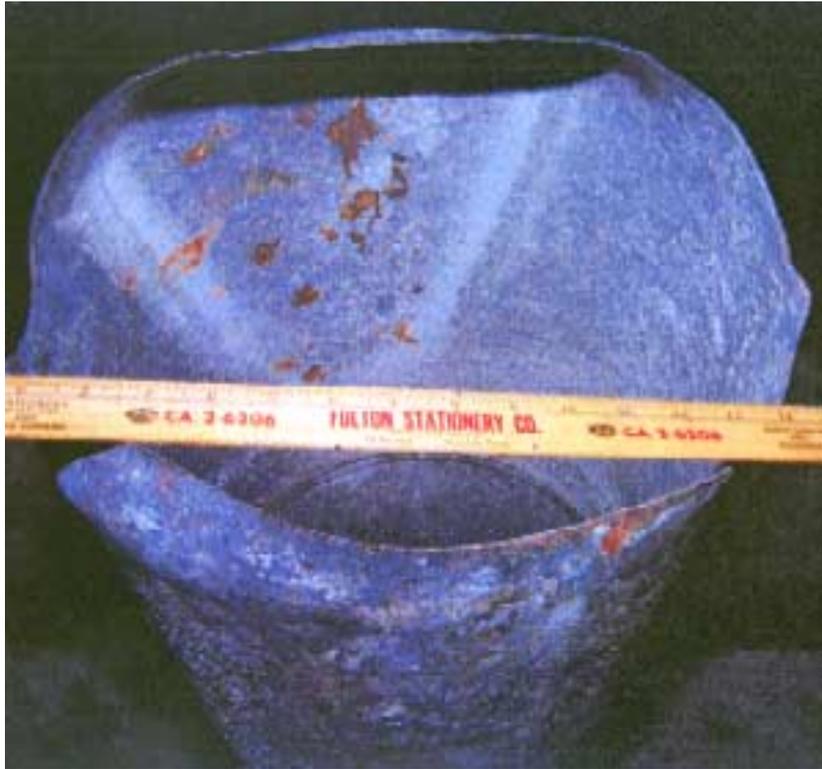
Office of Special Counsel gas dispersion expert, Dr. Jerry Haven, informed us that based upon his review of video, photographs, and analysis, he concluded that the propane tank in question was damaged by a phenomenon called a BLEVE. This phenomenon is caused by a build up of temperature and pressure inside the propane tank from the fire

that caused the tank to explode at its weakest point. The point is generally a welding seam located on the tank.

Figure 20: The above photograph exhibits a view of the damaged edge of the questioned propane tank.

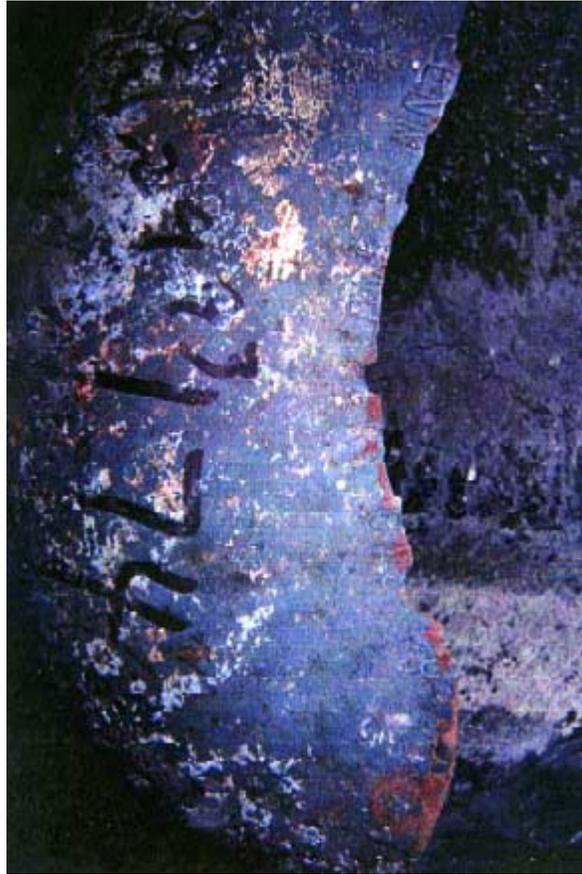
Figure 21: The above photograph depicts a close view of the edge of the questioned propane tank. This area was the region that was “swabbed” by Mr. Green.

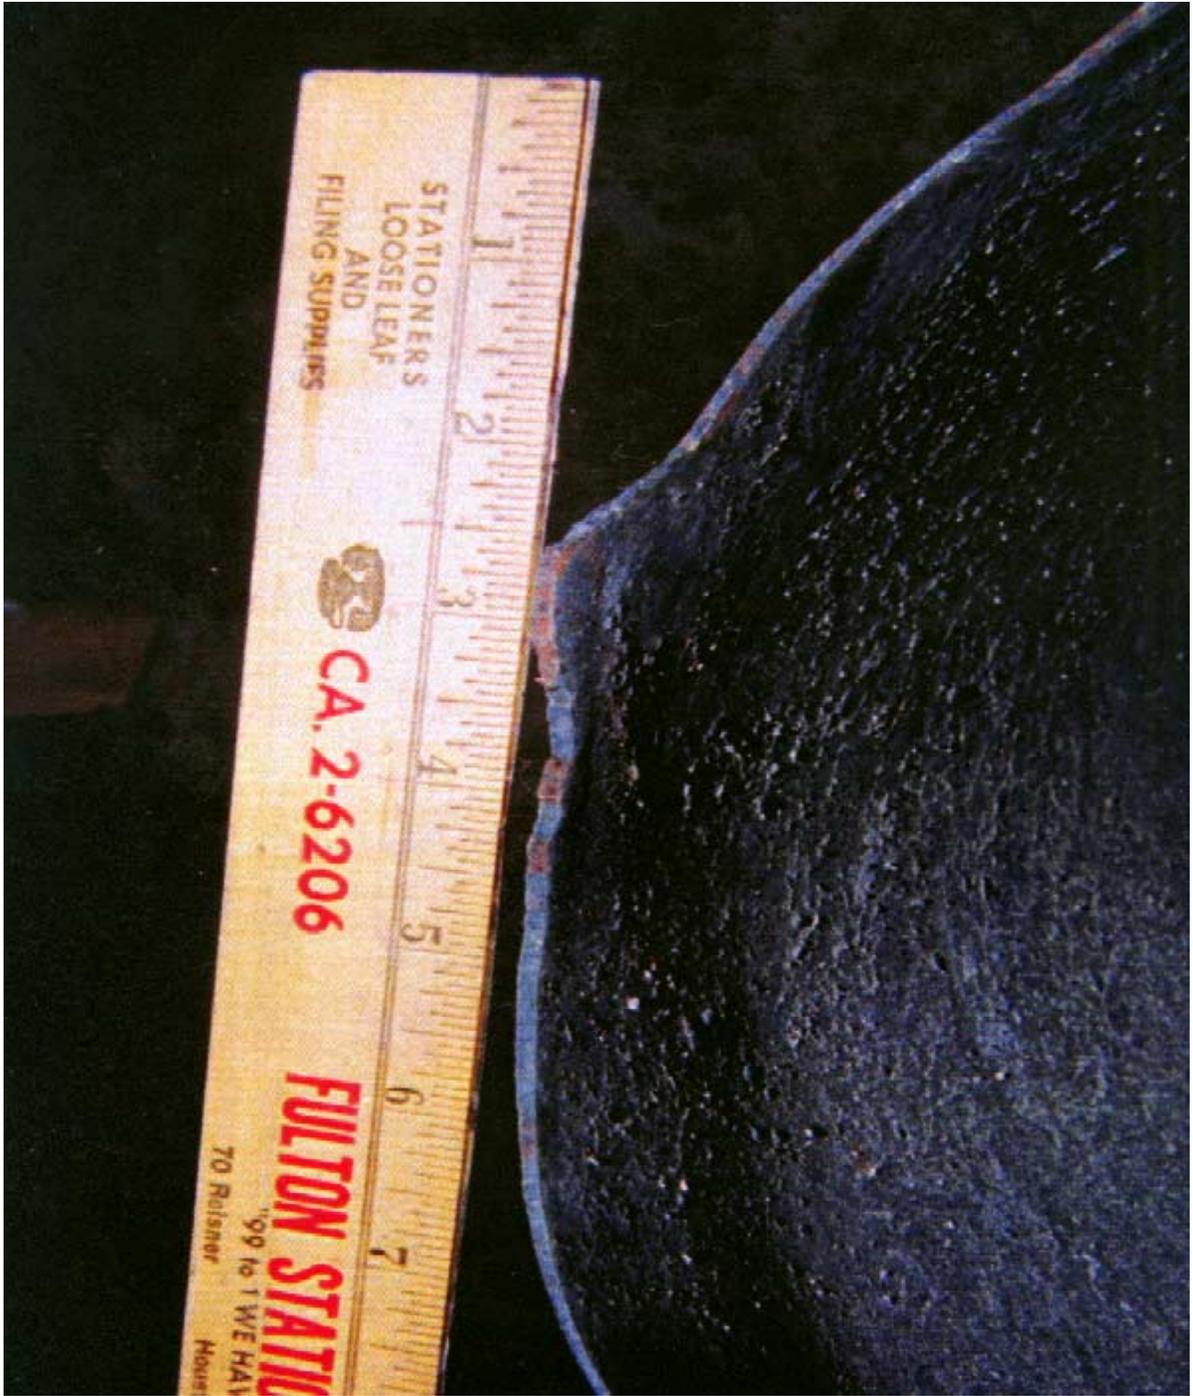
Figure 22: The above photograph depicts a close view of the edge of the propane tank
